Testing Laboratory OBRC SPEC S.A. in Warsaw

## Quality Assessment of Joint Sleeves for Preinsulated Pipes

### Ground Load for Preinsulated Pipe Joints (Sandbox Test and Water Impermeability Test)

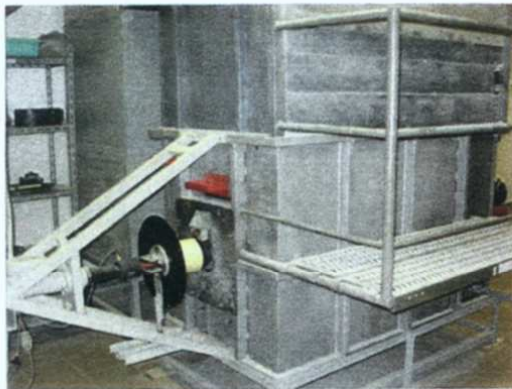
**Figure 1.** Sand box

Sandbox tests and water impermeability tests are one of the most important research carry out in the laboratory, because it verifies the quality of joints technical solution. After the ground load test (*figure 1*), joints are put on leak proof test by immersing in water (*figure 2*). Properly mounted joints should be tight after ground load test in case filled with sand and after water impermeable test.

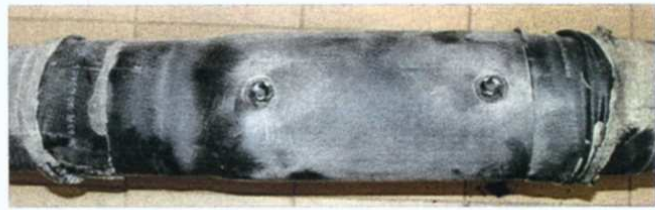
**Figure 4.** Thermo-shrinkable tube joint sleeve radiational cross-linked with thermo-shrinkable bands, 100 cycles, tight after test

*Figure 4* presents a tube joint sleeve radiational cross-linked with additional thermo-shrinkable bands, as the second tube sleeve insulation. After the test carried out in case filled with sand (100 cycles), because of improper technical parameters of thermo-shrinkable material (poly-isobutylene PIB) mastic gum without adhesive glue, the bands were destroyed. But apart from that fact the joint after the water impermeable test was tight. It should be added that thermo-shrinkable bands, applied for tube joint sleeve ends insulation, were produced by the leader of thermo-shrinkable market. However, according to information obtained in internet, they did not pass the tests in case filled with sand performed according to the method valid in EN 489 Standard dated on 2005. It is very significant information for both preinsulated pipe producers, who sell joint casings with additional insulation made of thermo-shrinkable bands, and for investors, who use thermo-shrinkable bands for preinsulated pipe insulation.

bands (compare with figure 4 after ground load tests) or improper shrinkage of not cross-linked thermo-shrinkable sleeves at casing pipe or bad protection of assembly openings in casing.

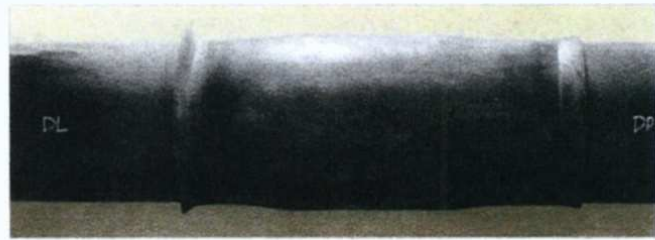
**Figure 6.** Tube joint sleeve electrically welded, 100 cycles, tight after test

Joints with electrically welded casings (*figures 6, 7, 8 and 9*) are always subject to smaller or bigger deformation at the sleeve ends (*figures 6, 7 and 8*), during tests, and just like presented in *figure 9* – muff made of polyethylene, the deformation is also visible at the casing's edge beyond the welding area. The deformation of electrically welded

muffs/sleeves does not always lead to leakage, but the fact that it takes place, confirms the necessity of performing the welding process strictly according to joints producer guidelines – the right time duration, with right casing pressure to the polyethylene screen, usage of current with proper parameters. The figures

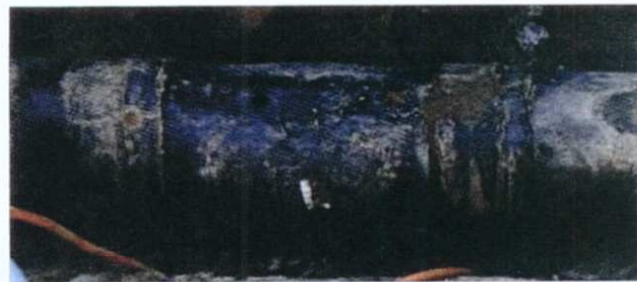
**Figure 10.** Thermo-shrinkable tube joint sleeve not cross-linked with thermo-shrinkable bands

Figure 10 shows a thermo-shrinkable tube joint sleeve not cross-linked with thermo-shrinkable bands, on the supply pipeline located in water logged area, after 4 years of operating. The pit was done, because the alarm system detected the leakage in the joint. In that case the cause of underground water penetration to the joint might have been the application of improper material for thermo-shrinkable

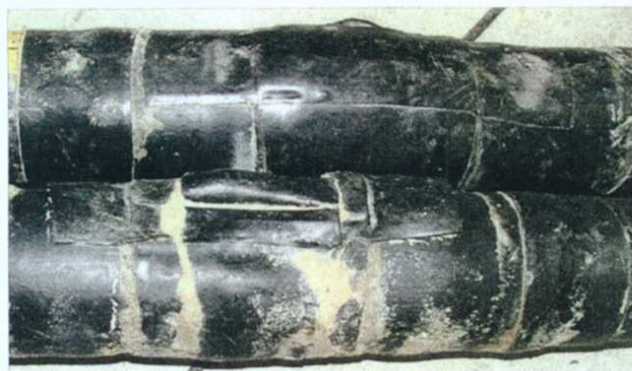
**Figure 11.** Joint sleeve set – supply (in the front), return with not cross-linked, thermo-shrinkable sleeves

Figure 11 presents a unit of joints disassembled after 4 years of operation and handed over to the laboratory in November 2009 from a Polish district heating company for examination. The technical state of the DN 80 joints disassembled from supply and return pipeline was very bad – both were uptight, which was the cause of occurring few factors including

- improper assembly of joints,
- bad sealed assembly openings in sleeves,
- application for sleeve ends insulation, thermo-shrinkable band with insulating mastic gum without glue, which does not prevent moisture penetration to joints,
- application at inner area of not cross-linked thermo-shrinkable sleeves, a thermo-fusible glue with improper quality, which was not able to bear the loads during functioning of pipeline and was not a durable insulation.

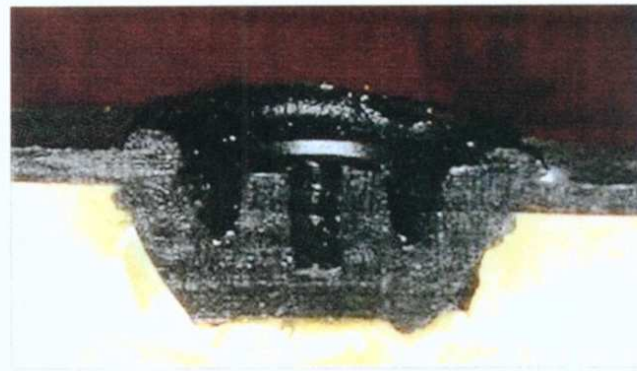
**Figure 12.** Welded plug (melted-in)

nection – apart its edges – are assembly holes. The experience indicates that the most durable protection of assembly holes against moisture penetration to the joint are melted-in polyethylene (PE) plugs – figure 12. The application of thermo-shrinkable patches and plugs drove, screwed in or glued in, in most cases do not bring expected results, as were proven by test performed by different users of district heating system. By improper protected assembly holes as well as by badly shrunk or welded sleeves/muffs, ground water may penetrate to the joint, which can cause moisture and after some time insulation degradation (figure 13) and corrosion of pipelines (figure 14).

In Warsaw district heating system at preinsulated pipelines located directly in the ground DN 32 to 300, as well as in many other cities, sleeves/muffs with welded in plugs (melted in) radiational cross-linked are applied and at connections of pipelines DN  $\geq 350$  sleeves/muffs electrically welded.

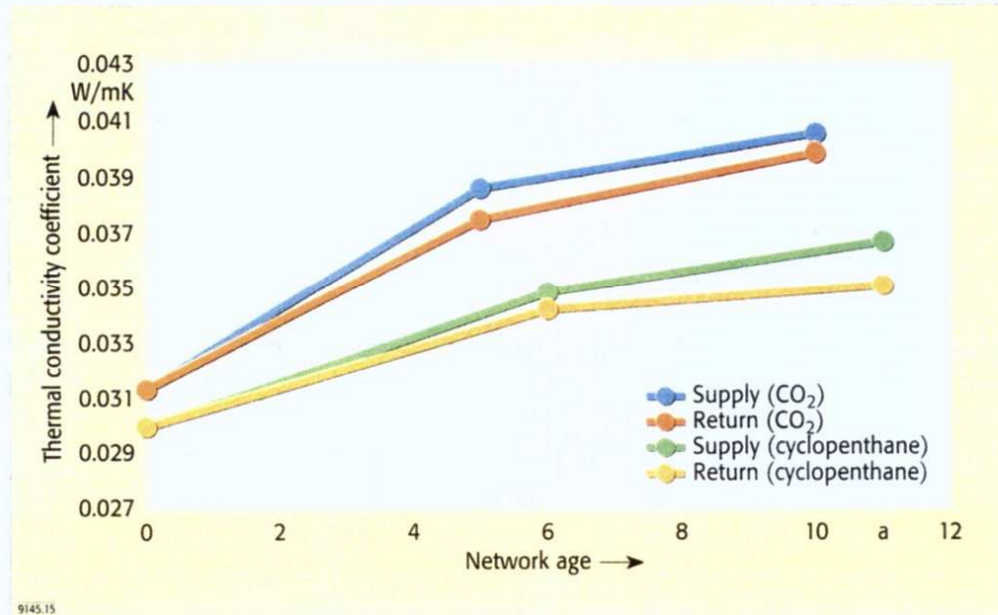
**Figure 15.** Dependence between thermal conductivity coefficient for preinsulated pipes insulation and also functioning of preinsulated pipeline

Figure 15 shows the dependence between the value of thermal conductivity coefficient for insulation made of preinsulated pipes and the time of preinsulated pipeline operation – top two lines: PUR foam expanded with CO<sub>2</sub>, bottom two lines: PUR foam expanded with cyclopentane.

In 2006, 2007 and 2008 tests concerning 10 samples – insulation made of preinsulated pipes, foamed with carbon dioxide, disassembled from Warsaw district heating system, were carried out. The results of performed tests allow to make a statement that the mean value of thermal conductivity coefficient of insulation foamed with carbon dioxide varies of about 23 % after 5 years of operation in supply pipeline, and 19 % in return pipeline. After 10 years of operation the values vary about 29 % in supply pipeline, and about 27 % in return pipeline.

show that samples foamed with cyclopentane have better thermal characteristics after some time of operation than samples foamed with carbon dioxide. They change after about 6 years in supply pipeline of around 16 %, after 11 years in supply pipeline of around 17 % and in return pipeline after around 6 years of around 14 %, in supply pipeline of around 22 %.

The test results confirmed that in case of failure – joint leakage and water penetration inside the foam, deterioration of thermal parameters of insulation occur in shorter time. Wet foam from preinsulated pipeline after around 4 years of operation has a little bit worse thermal parameters than dry foam after 6 years of operation.
